# FAILURE ANALYSIS OF A GLASS FILLED PHENOLIC RESIN POWER STEERING PUMP PULLEY

A root cause failure analysis was performed on a glass filled phenolic resin power steering pump pulley that was implicated in an automobile accident. A thorough investigation including vehicle inspection, macroscopic and microscopic examination, stress analysis, and exemplar testing was performed to test two competing hypotheses postulated to explain the failure. The first hypothesized cause of failure was the impact of the pulley with other under-the-hood components during a rear end impact. The second hypothesized cause was fracture due to fatigue, which was the result of various defects. This paper details the various investigative steps and identifies the ultimate root cause.

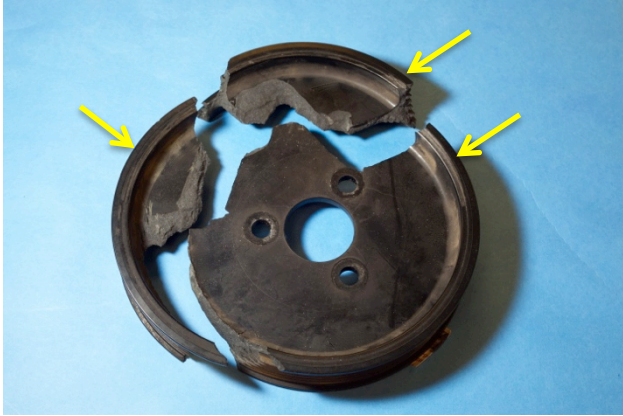
The authors have investigated the fracture of a power steering pump pulley associated with a fatal accident involving an automobile. The pulley, shown in Figure 1 is made of a mineral and glass fiber filled phenolic thermoset resin ("Bakelite"). The pulley is mounted onto a triangular steel plate with a center boss that is then mounted onto the shaft of the power steering pump (Figure 2). Conflicting witness reports suggest that either a failure caused the vehicle to come to an abrupt stop or the vehicle was stopped with the engine idling. In either scenario, the vehicle was stationary on the highway when it was struck from behind by an oncoming vehicle that was traveling at or near the posted speed limit. The cause of the pulley failure was disputed in subsequent litigation. One of the investigators argued that the fracture of the pulley induced a sudden loss of power thereby causing the engine to cease running and precipitating the accident. However, an accident reconstruction expert opined that the engine was idling at the time of impact. This analysis was based on a review of the engine control module (ECM) data.

- A macroscopic fracture pattern suggestive of bending loads, e.g. an angled fracture surface.
- Witness marks along the circumference of the pulley's outer flange that spans multiple pieces, as shown in Figure 1, suggesting contact of the pulley with another object.
- Damage to the V-belt (not shown)
- Damage to the radiator fan shroud (not shown)
- Witness marks on the coolant overflow tank (not shown)
- Fracture of both the driver's side and passenger's side engine mounts (not shown)
- The transmission mounts were intact.
- Other various damage in the engine compartment

The damage pattern suggests that the pulley came into contact with the coolant overflow tank and/or the radiator fan shroud during the incident. Damage to the engine mounts confirms that the engine could have displaced forward to cause the contact, and this motion was possibly associated with the vehicle coming to an abrupt stop after impact due to substantial damage resulting from the rear-end collision. The continuous witness marks across multiple pieces of the pulley also suggest that the pulley was rotating during the impact.

This observation contradicts the allegation that the pulley failure occurred prior to the impact.

Figure 1. Subject power steering pump pulley. Witness marks indicated.

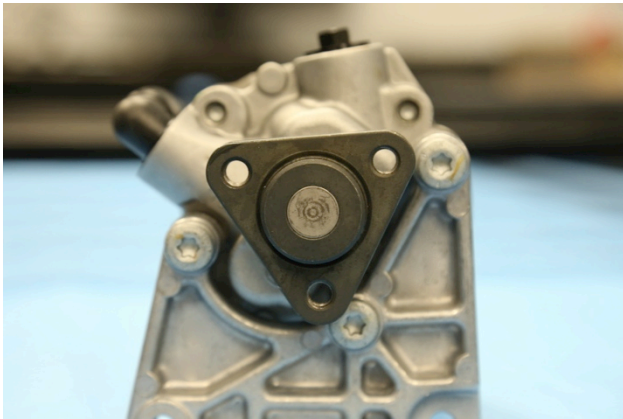
The opposing party also argued that the choice of a triangular mounting plate was inappropriate as it generated a significant stress concentration and therefore represented a design defect. The location of the crack origin at or near the apex of the plate was used to support this hypothesis. However, the initiation of fracture at this location is also consistent with impact (see exemplar test results below) and therefore inconclusive. In addition, the stresses during normal operation were determined to be negligible through finite element analysis (FEA), as discussed next.

Figure 2. Power steering pump with triangular mounting plate (pulley not installed).

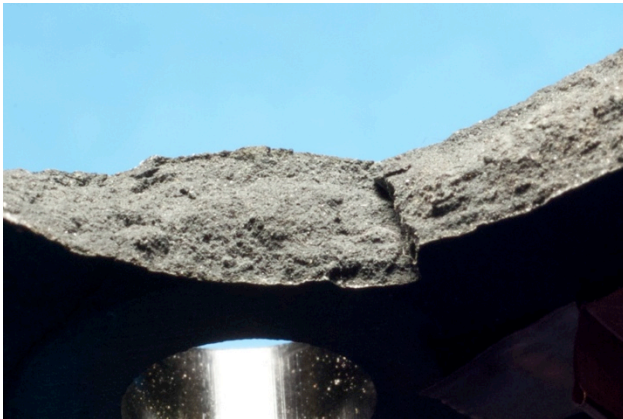
Next, the subject pulley was examined in greater detail using a stereomicroscope (Figure 3) and a Scanning Electron Microscope (SEM). Little to no fractographic detail in the phenolic resin matrix was discernible. This is not unusual for highly filled resin. The fracture surfaces of individual fibers were also studied. The fracture surface of the glass fibers demonstrated classical mist, mirror, and hackle features indicative of brittle fracture, as shown in Figure 4. No evidence of features that can be attributed to fatigue, environmental stress cracking, or chemical attack was observed.

Figure 3. Fracture surface of subject pulley near the likely origin.

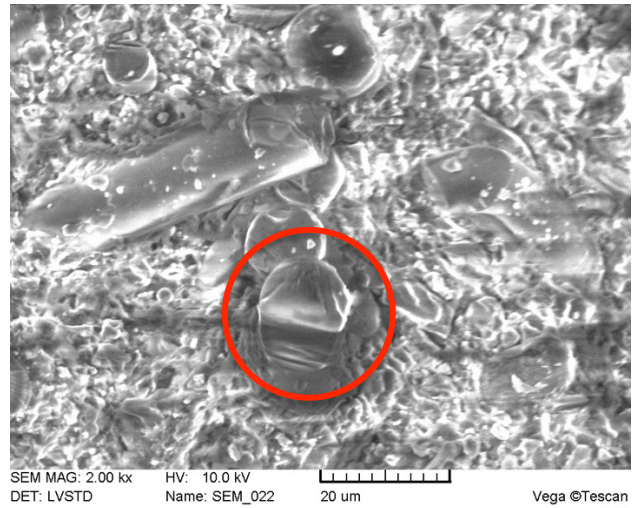
However, another party argued that the hackled portion of the fracture surface on some of the glass fibers was actually a second crack origin growing from the opposite side of the glass fiber, and they attributed this two-sided crack propagation to fatigue. This interpretation is flawed for two reasons. First, such a phenomenon would require loading individual fibers in reversed bending, which is unlikely given the geometry and loading. Second, the appearance of the alleged second origin can be explained as follows. During tensile loading of a fiber within a composite, tensile and shear stresses (and strengths) compete. Typically, the crack initiates and grows perpendicular to the long axis of the fiber, but in some cases, shear dominates and the crack grows on an angle, i.e. normal to the direction of shear stresses. This is illustrated in Figure 5. The result can be a hackle zone that is not planar with the origin, but rather angled [8].

Figure 4. SEM micrograph of the subject pulley fracture surface showing representative fiber fractures.

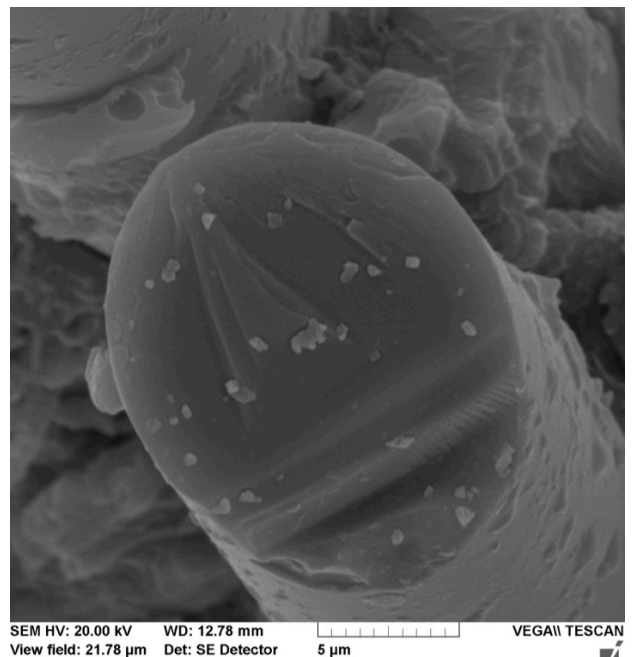
To further illustrate this principle, the authors performed an impact test following ASTM D6110-10 (Charpy impact) [18] on an un-notched coupon of material cut from the flat disk web section of an exemplar pulley. Fracture surfaces on representative glass fibers are shown in Figures 7 and 8. Comparing these images to those from the subject pulley (Figure 4) confirms that the fibers in the subject pulley fractured in a manner consistent with classical brittle fracture due to overload. Thus, this particular physical evidence does not rule out the possibility of impact failure.

Figure 6. Typical fiber fracture from Charpy impact specimens from an exemplar pulley.

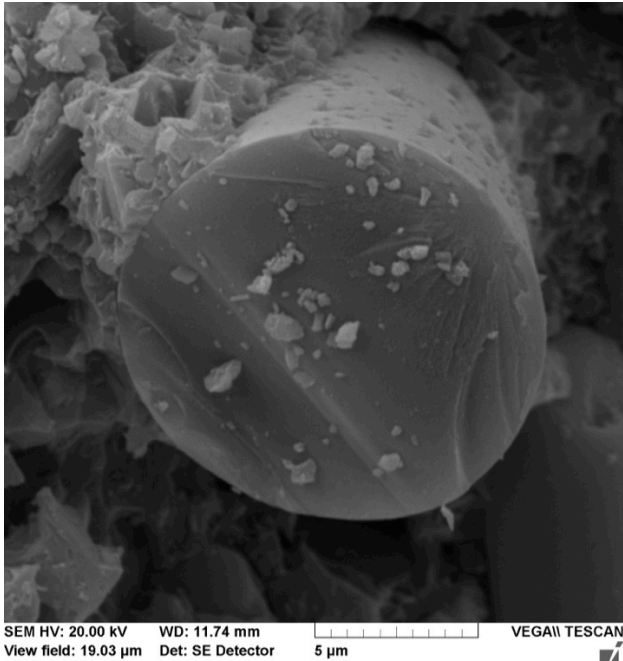
Figure 7. Typical fiber fracture from Charpy impact specimens from an exemplar pulley.

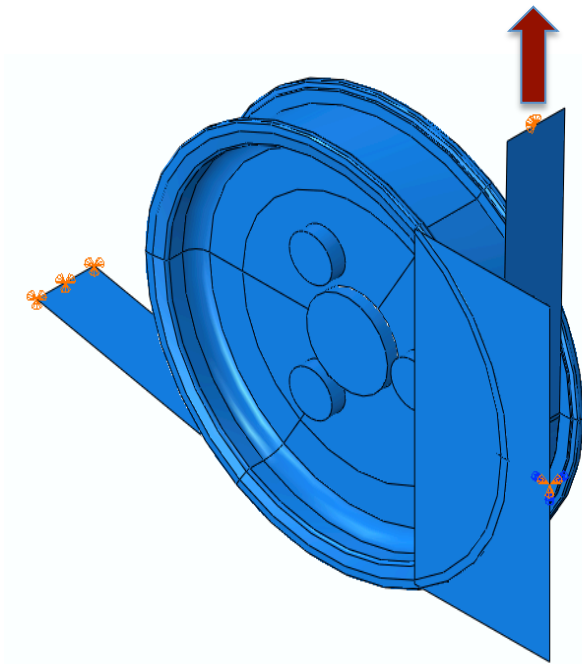
In accordance with the ECM data, i.e. assuming the vehicle to be idling at the time of impact (no pulley acceleration), a tension load was applied to the upper belt end in Figure 8. The bottom end was constrained against axial motion to provide an opposing force and maintain static equilibrium. In order to establish the operating tension on the serpentine V-belt, belt tensions were measured on an exemplar vehicle before and after replacement of its belt during regular maintenance.

Figure 8. Finite element model. Belt load indicated. The impacted body (overflow tank) is represented as a rigid surface that contacts the pulley along a portion of the outer flange.

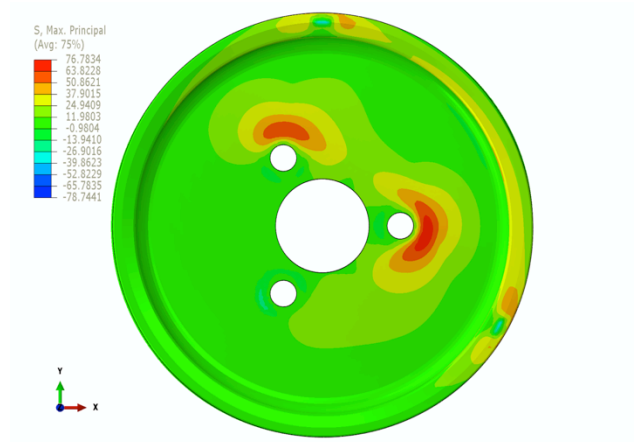
- The effect of preload is negligible. The tensile stresses are very small (20% of the reported tensile strength and 10% of the flexural strength). The only sizeable stresses are compressive and therefore not likely to initiate cracking.<sup>2</sup> Furthermore, the peak compressive stress is 54% of the compressive strength.
- Belt tension during idling also has little effect.
- Comparing the edge loading results to the flexural strength of the material suggests an ultimate load capacity of approximately 2050 N (460 lbs) with this force distributed along a portion of the pulley’s flange.
- The stress distribution around the bolt holes is consistent with the crack patterns documented above, predicting the initiation of both circumferential and radial cracking at both holes (Figure 9).

Figure 9. Maximum principal stress distribution for edge loading with the pulley rotated such that the contact points are  $30^\circ$  away from the bolt holes.

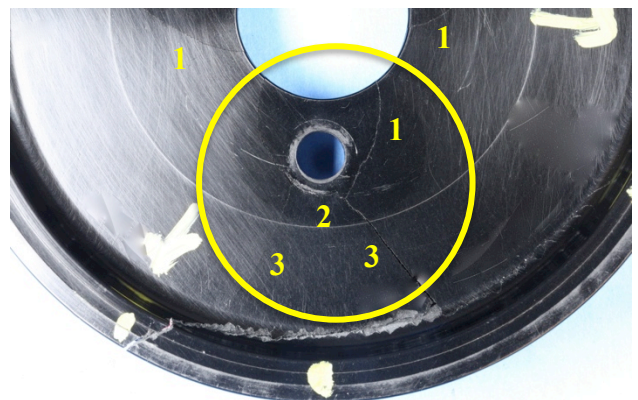
The load to induce cracking varied between 2470 N (555 lbs) and 2740 N (617 lbs) for four exemplars. A sample tested following the method above with the loads rotated  $30^\circ$  from the nearest mounting holes is shown in Figure 11. The crack pattern is characterized by "radial" cracks on both sides of the hole located between the loading points (labeled 1 in Figure 11), a circumferential/transverse crack along the apex of the triangular mounting plate (opposite side) (2), and a  $45^\circ$  angle crack that emanates off the transverse crack and grows outward to the flange, where it then turns to propagate circumferentially (3). All of these features are consistent with the subject pulley (Figure 12). A single radial crack is found to be associated with each of the other two holes, as well.

Figure 11. Close-up of exemplar pulley loaded under two-point loading.

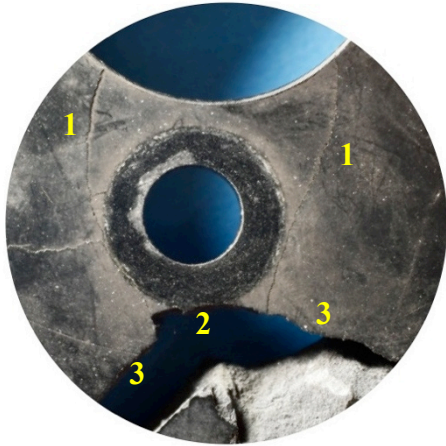
Figure 12. Close-up of cracking on outboard face of subject pulley.

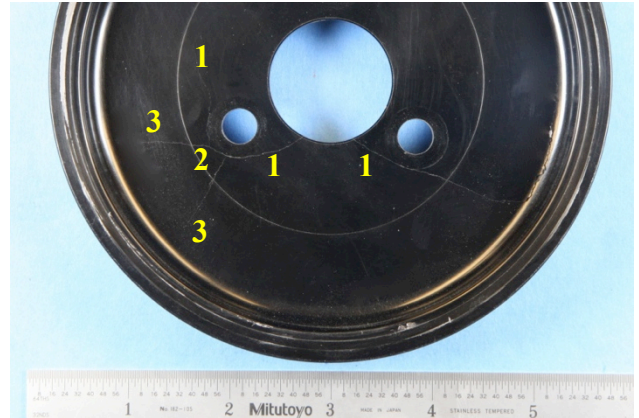
The fracture patterns on the tested pulleys and witness marks on the coolant tank test coupons were examined. Again, the crack pattern was very similar to the subject and static tested pulleys (Figure 15). Furthermore, witness marks similar to those on the subject overflow tank were found on the exemplar overflow tank samples (not shown).

Figure 15. Crack pattern on an exemplar pulley resulting from dynamic impact.

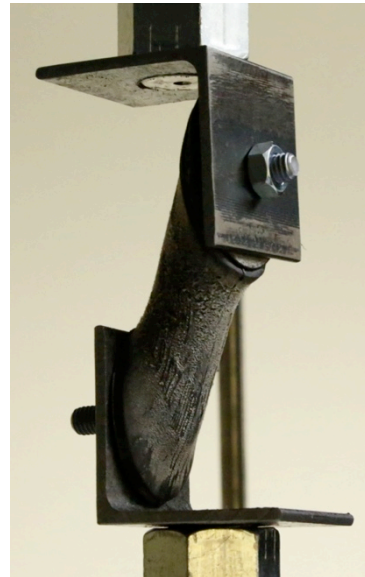
Both types of mounts were found to exhibit considerable ductility due to their primarily rubber construction, but the engine mount was found to fail at a smaller displacement (8.1 cm, as opposed to 11.1 cm for the transmission mount). This result is consistent with the observation that the transmission mounts had not failed.

Figure 16. Transmission mount during shear test.
