INNOVATIVE PVC WATER PIPE Flexibility for the Future

Modernizing Distribution

What is i(nnovative)PVC?

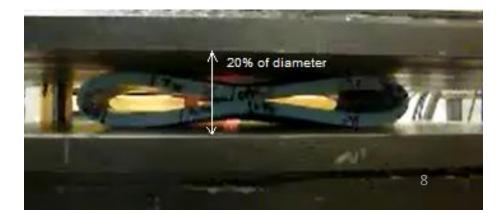
Stiffness Test (ASTM D2412)

- 5% steps of deformation from 95% through 20% deflection
 - Reached 95% OD at 451 psi at 95% OD, >23% over standard
 - Deformed below 20% pipe O.D. no wall cracking
- Maximum load- 10,100 psi

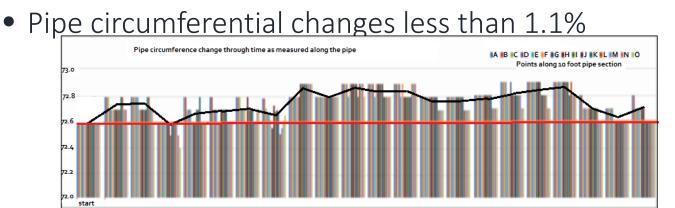
Fatigue Test (UTA Configuration)

Surge Pressure Setup

• 10 foot (3m) pipe cycled between 150 -225 psi

- 4 Million cycles 7 cycles/minute 8 months
- Water temperature maintained 60°F 65°F

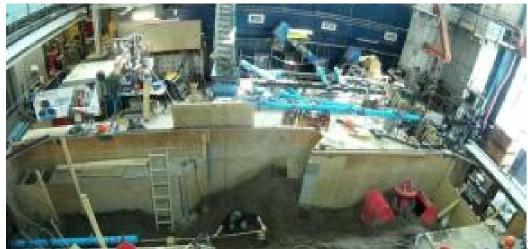
Earthquake Simulation

- University of Cornell School of Civil & Environmental Engineering
 - Cornell Large Scale Lifelines Testing Facility in the Bovay Laboratory Complex
 - Have performed earthquake related testing of ductile, iron, steel and PVC pipes
- Tests performed
 - Tensile tests
 - Compression test
 - 4 Point Bending test
 - Soil Axial test
 - Split Basin test

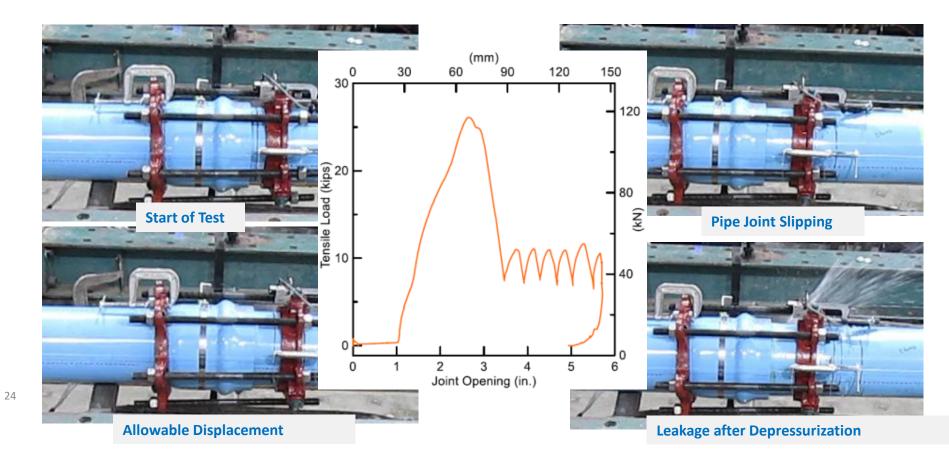
Pipe Tensile Test

- Two tests performed with spigot completely inserted into the bell
- Six 0.75 in. (19 mm) threaded rods spanned the restraints at either side of the joint.
- Nuts on restraining rods were loosened to allow 1 inch. (50 mm) of pullout before engagement.
- The pipe was pressurized with water to approximately 80 psi (550 kPa) during the tests and then tensile force applied at one end.

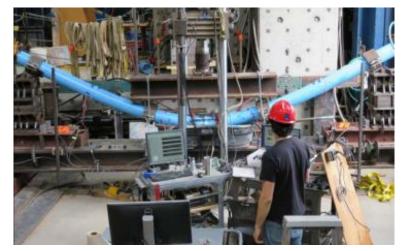
Four Point Bending Test

- Testing limits of restrained joint deflection
- Pressurized pipe is supported at 2 locations on both sides of joint.
- Deflection increased, paused at 10 inches and 18.5 inches, to observe.
- Test ended at 27 inch deflection, limit of equipment
- No leakage or loss of pressure

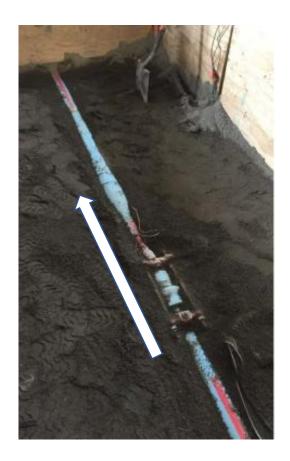
Soil Axial Test

- Assess the resistance pipe joints and restraints to relative axial slip with soil
- Tests performed with 2.5 ft (0.75 m), 3.5 ft (1.1 m), and 4.5 ft (1.4m) of soil cover over pipe
- Resistance depends on pipe geometry, depth, and soil strength (not pressure).
- Pipe pulled 30 in. (760 mm) through soil at a rate of 1 in. (25.4 mm) per minute.

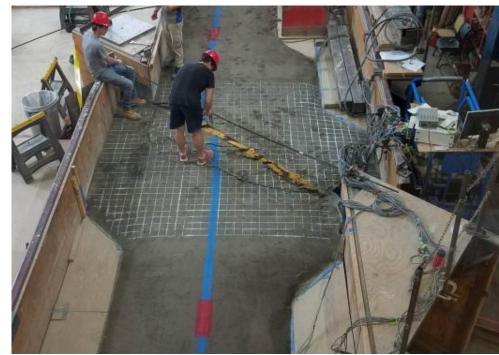
- Causes soil rupture and slip at the interface between the two parts of the test basin.
- Increasing both bending and tension stress
- Matches most severe seismic ground deformation, liquifaction

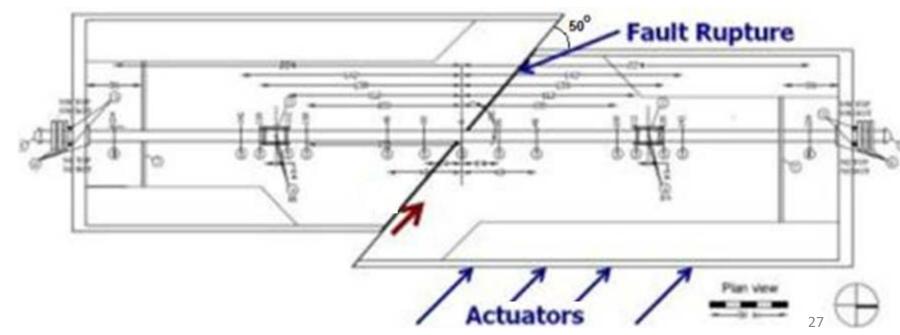
• Simulating ground shift to stretch and bend pipe

- The split basin test June 19, 2018
- 3 pipe segments connected with joint restraints at bell and spigots
- buried in test basin granular backfill approximately 2.5 ft (0.76 m) of cover.
- The south part of the basin remains stationary, while the north part is shifted

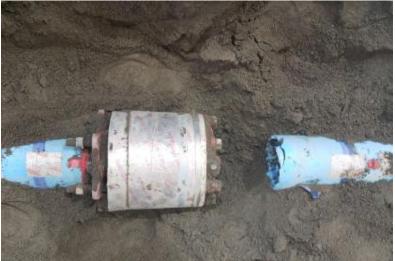
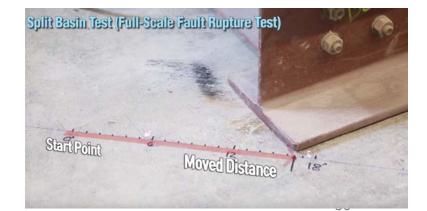
Split Basin Test (Full-Scale Fault Rupture Test)

Moving North part to the North and West for 2 inch per minute

- Extended 16.4 inches before pipe lost pressure at fixed end joint.
- Tension pull 10.5", Bending 12.5"

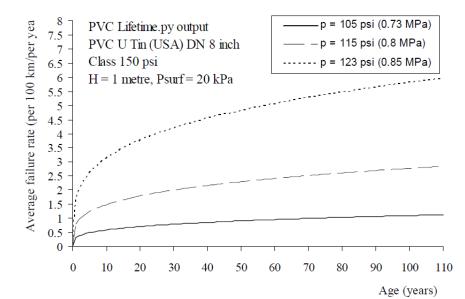
Thickness, Pressure Matters

• For standard PVC, studies have shown thicker pipe is more resilient to higher pressure, surge and offer greater life (CSIRO)
