# FAILURE ANALYSIS OF A GLASS FILLED PHENOLIC RESIN POWER STEERING PUMP PULLEY

A root cause failure analysis was performed on a glass filled phenolic resin power steering pump pulley that was implicated in an automobile accident. A thorough investigation including vehicle inspection, macroscopic and microscopic examination, stress analysis, and exemplar testing was performed to test two competing hypotheses postulated to explain the failure. The first hypothesized cause of failure was the impact of the pulley with other under-the-hood components during a rear end impact. The second hypothesized cause was fracture due to fatigue, which was the result of various defects. This paper details the various investigative steps and identifies the ultimate root cause.

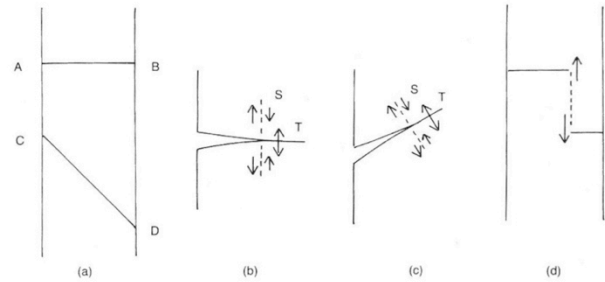
Figure 5. Courtesy Hearle et al. [9]

However, another party argued that the hackled portion of the fracture surface on some of the glass fibers was actually a second crack origin growing from the opposite side of the glass fiber, and they attributed this two-sided crack propagation to fatigue. This interpretation is flawed for two reasons. First, such a phenomenon would require loading individual fibers in reversed bending, which is unlikely given the geometry and loading. Second, the appearance of the alleged second origin can be explained as follows. During tensile loading of a fiber within a composite, tensile and shear stresses (and strengths) compete. Typically, the crack initiates and grows perpendicular to the long axis of the fiber, but in some cases, shear dominates and the crack grows on an angle, i.e. normal to the direction of shear stresses. This is illustrated in Figure 5. The result can be a hackle zone that is not planar with the origin, but rather angled [8].

Fig. 4.2 — (a) Plane of maximum tensile stress AB, and maximum shear stress CD. (b) Tensile (T) and shear (S) stresses near a crack tip. (c) Tensile (T) and shear (S) stresses when crack is angled. (d) Two separate cracks linked by a plane of high shear stress.

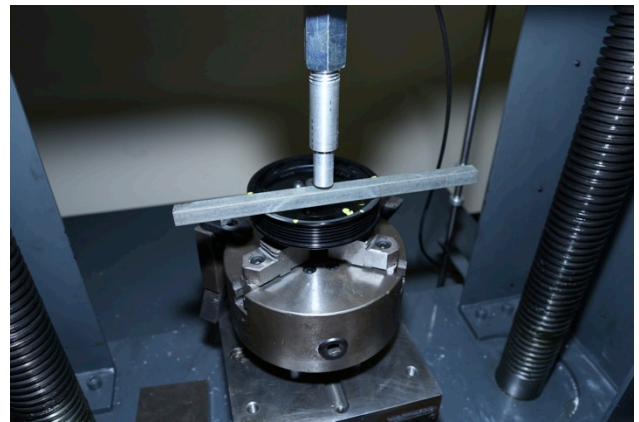
Figure 10. Static two-point bend test setup.

A static bend test of exemplar pulleys was developed to characterize the fracture behavior of the power steering pulley under transverse loading and to validate the FEA. The setup is shown in Figure 10. The pulleys were bolted to the triangular mounting plate using the three bolts spaced  $120^\circ$  apart, just as in the actual application. The mounting plate was then affixed to a rigid mount on the bottom of the load frame. Load was applied through an aluminum rod mounted on the upper, moveable platen of a universal test frame. Tests were performed for the load applied at various positions (i.e. rotations) along the circumference of the outer flange. Tests were run with the three mounting bolts hand tightened only or torqued to the specified torque of 21.4 N-m (189 in-lbs.). Load was applied at a quasi-static rate of 1 inch/min.

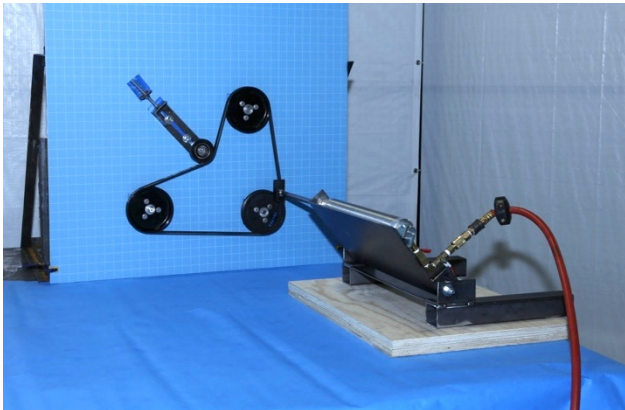
Figure 13. Overview of the dynamic impact test setup.

Next, a dynamic bend test of exemplar pulleys was developed to characterize the fracture behavior of the power steering pulley under transverse impact loading. The setup is shown in Figure 13 and Figure 14. This test effectively simulates the failure mode proposed by the authors albeit in a more controlled manner. For example, it assumes only fore/aft relative motion of the engine/pulley and overflow tank and neglects the possibility of contact with other components.

serpentine belt was tensioned to the exemplar vehicle value using an idler pulley affixed to an adjustable slide. One pulley (lower left of Figure 13) was driven using an electric motor. The serpentine belt then drove the other pulleys. The velocity of the electric motor was controlled using an AMETEK speed controller and verified using a EXTECH model 461891 digital contact tachometer.

A pneumatic actuator was attached to an adjustable frame (Figure 13). Exemplar coolant overflow tanks were sectioned, and a small test coupon was excised from the corners. These tank coupons were then adhesively bonded to the end of the actuator. The frame position could be adjusted to control the region of the tank test coupon that came into contact with the test pulley as well as the depth of penetration of the ram/tank test coupon through the contact plane with the test pulley. Again, the mounting bolt preload was varied. Through trial and error, it was determined that a cylinder load of approximately 1780 N (400 lbs) was required to fracture or significantly crack the pulley. This value, although lower, is consistent with the data from the static bend tests and stress analysis, considering dynamic effects such as impact factor and the strain-rate dependence of the polymer's strength.
