# Root Cause Analysis of Plastics Failures

Perry Sheth P.E  
SPE Plastic Pipe Conference  
Philadelphia, PA  
April 16-17 , 2019

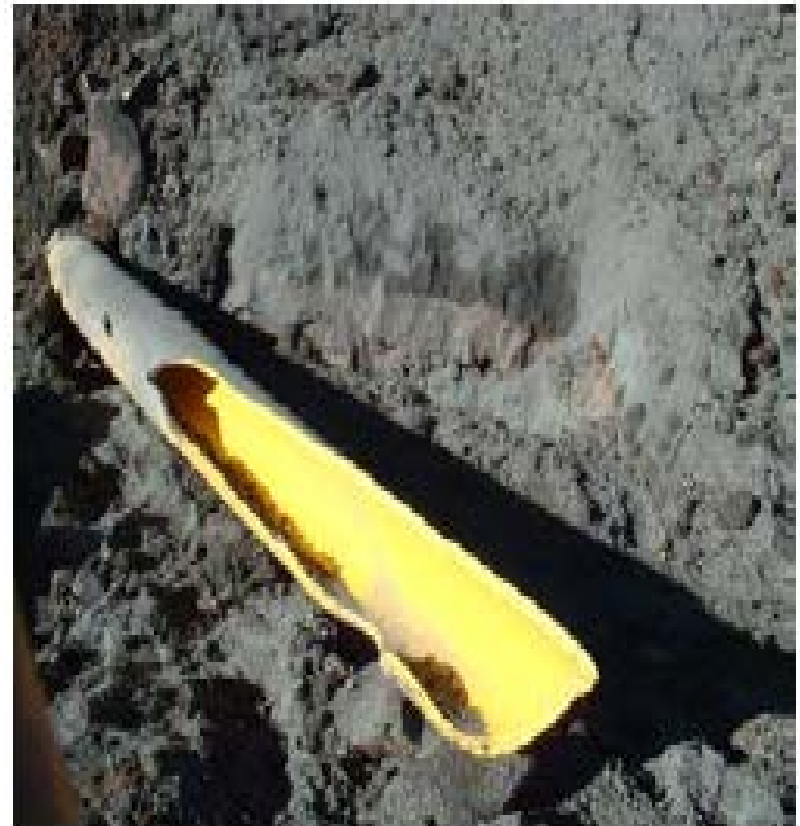
# **Sinusoidal type of failure**

**Circumferentially originated from the outside wall of the pipe**

**Generally attributed to the poor resistance to the rapid crack propagation called fast fracture or RCP**

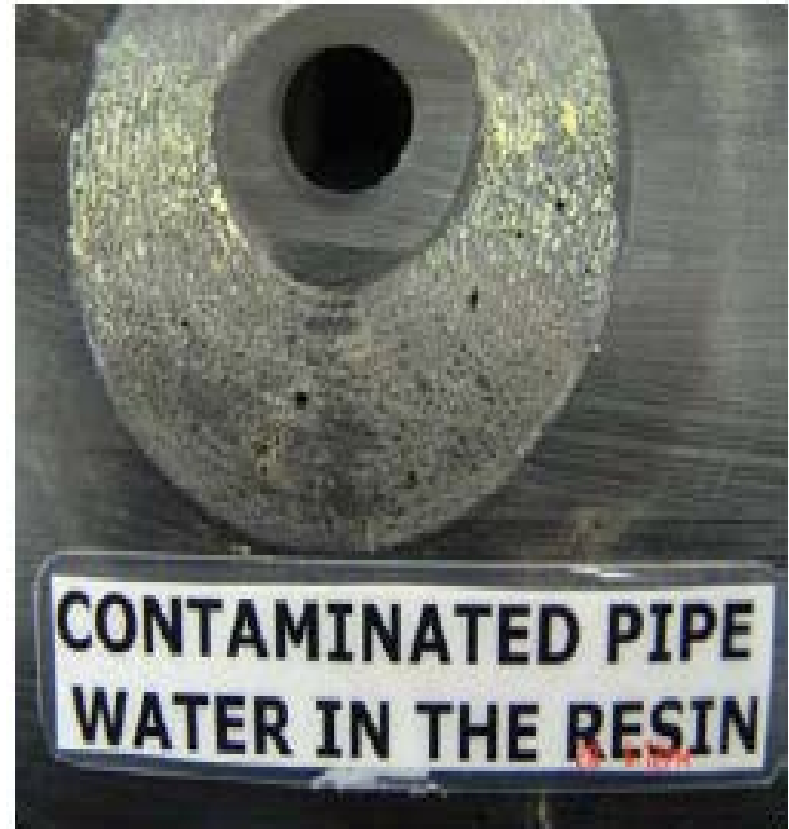
# Micro Holes

- Migration of water during extrusion of pipe
- Static discharge resulting from the poor dielectric strength of pipe
- The failure to remove moisture from hydroscopic materials can lower the overall physical properties of PE materials and in some cases can cause them to become brittle
- This can be visually seen by just heating the outside surface of the pipe with a heating iron

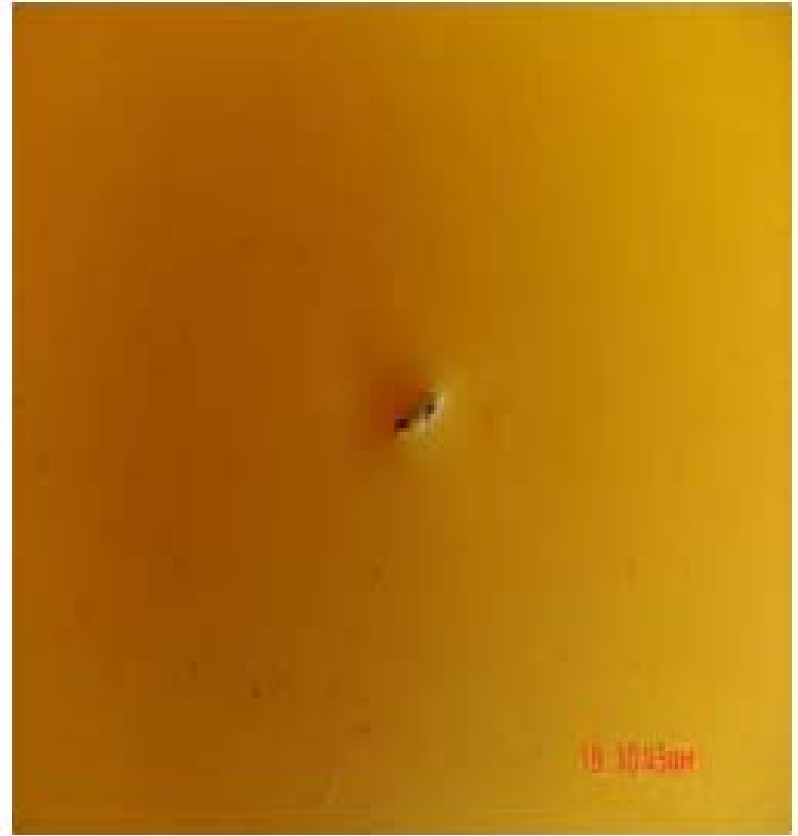
# Presence of Foreign Material

- Contamination can cause the part to fail.
- Burn marks such as brown streaks and black spots can cause failure
- These marks indicate the possibility of material degradation during processing causing the breakdown of molecular structure leading to overall reduction in the physical properties

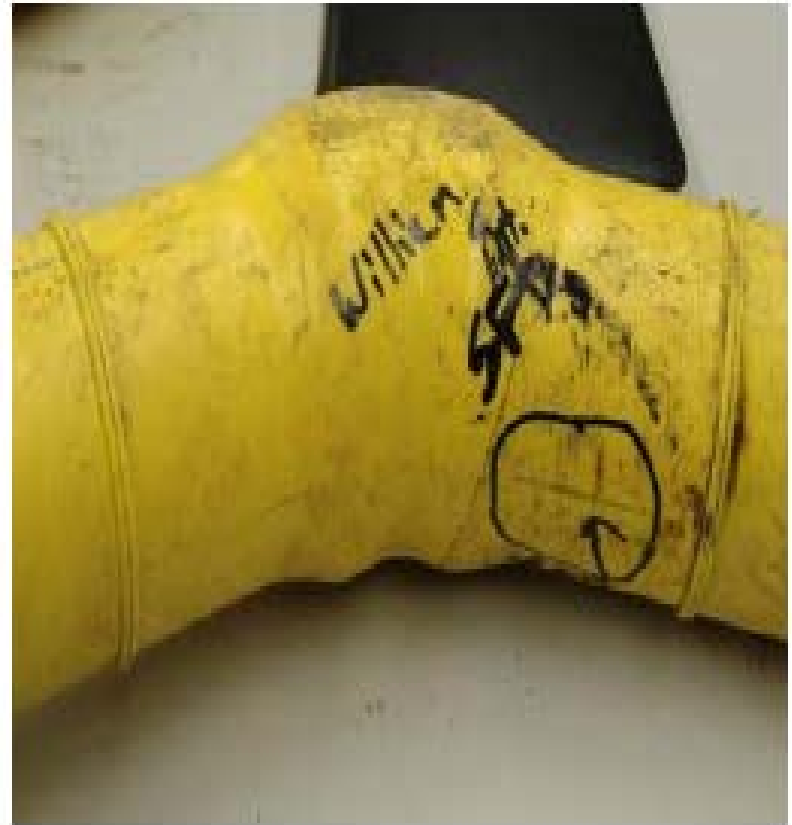
## Sink marks & weak knit lines

**Are readily visible on  
molded fittings,  
represent poor  
processing practices  
and may contribute to a  
part failure**
