End of Life Vehicle (ELV) Recycling – Bumper Fascia

SPE International Polyolefins Conference
Houston, TX February 24-27 2019

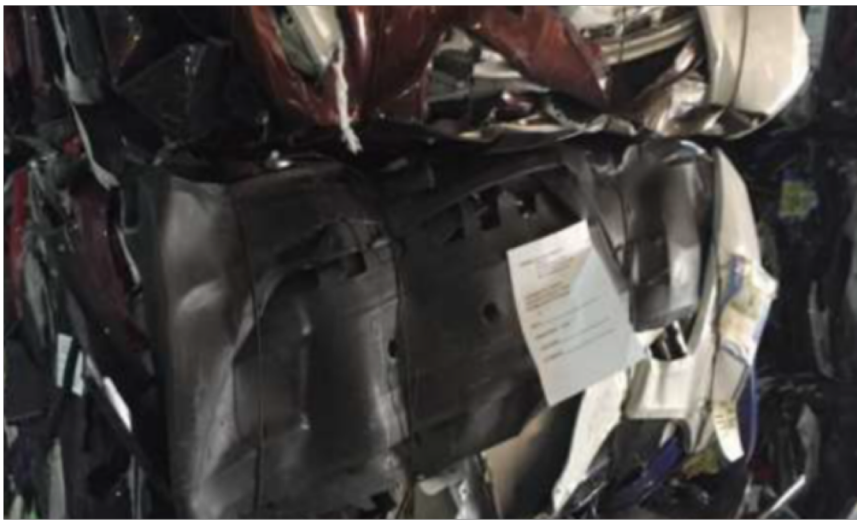
Baled fascia were received from Padnos auto scrap processing facility in Michigan

4000 lbs. of bumpers were collected

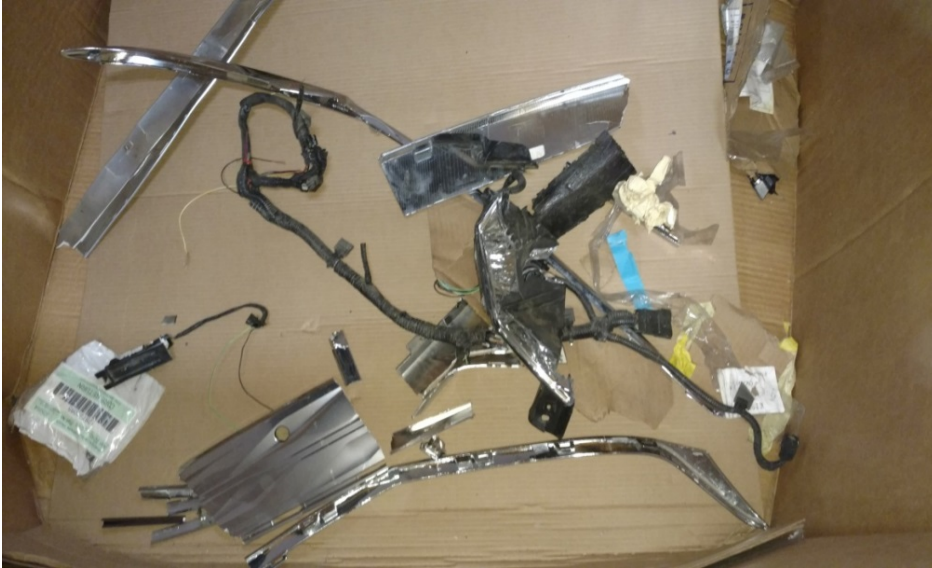
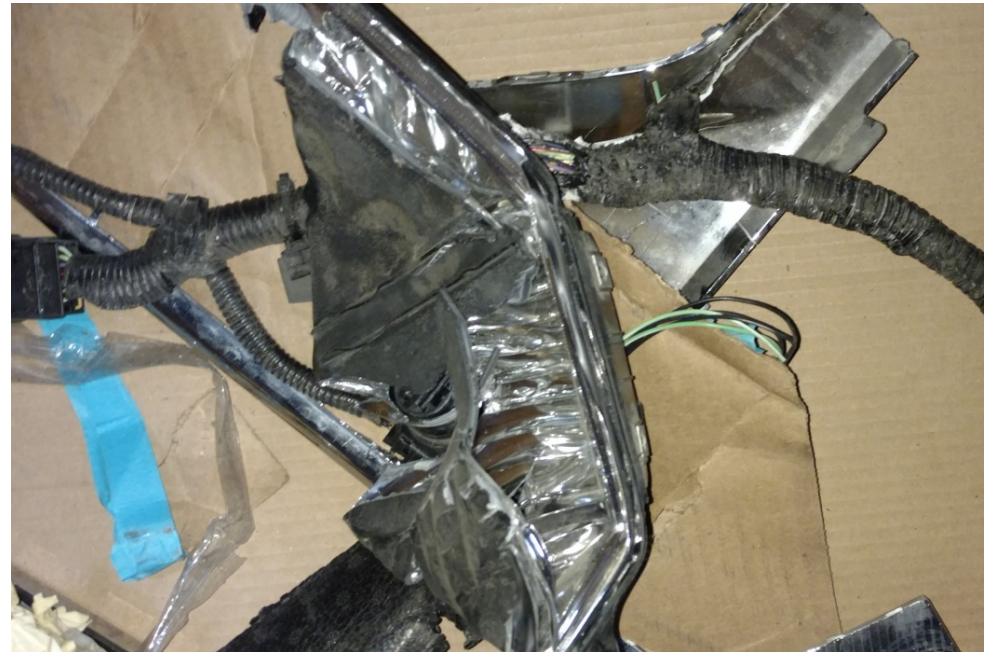
Non-TPO Items Removed

Examples of contaminants removed by hand

Close-up of lamp housing

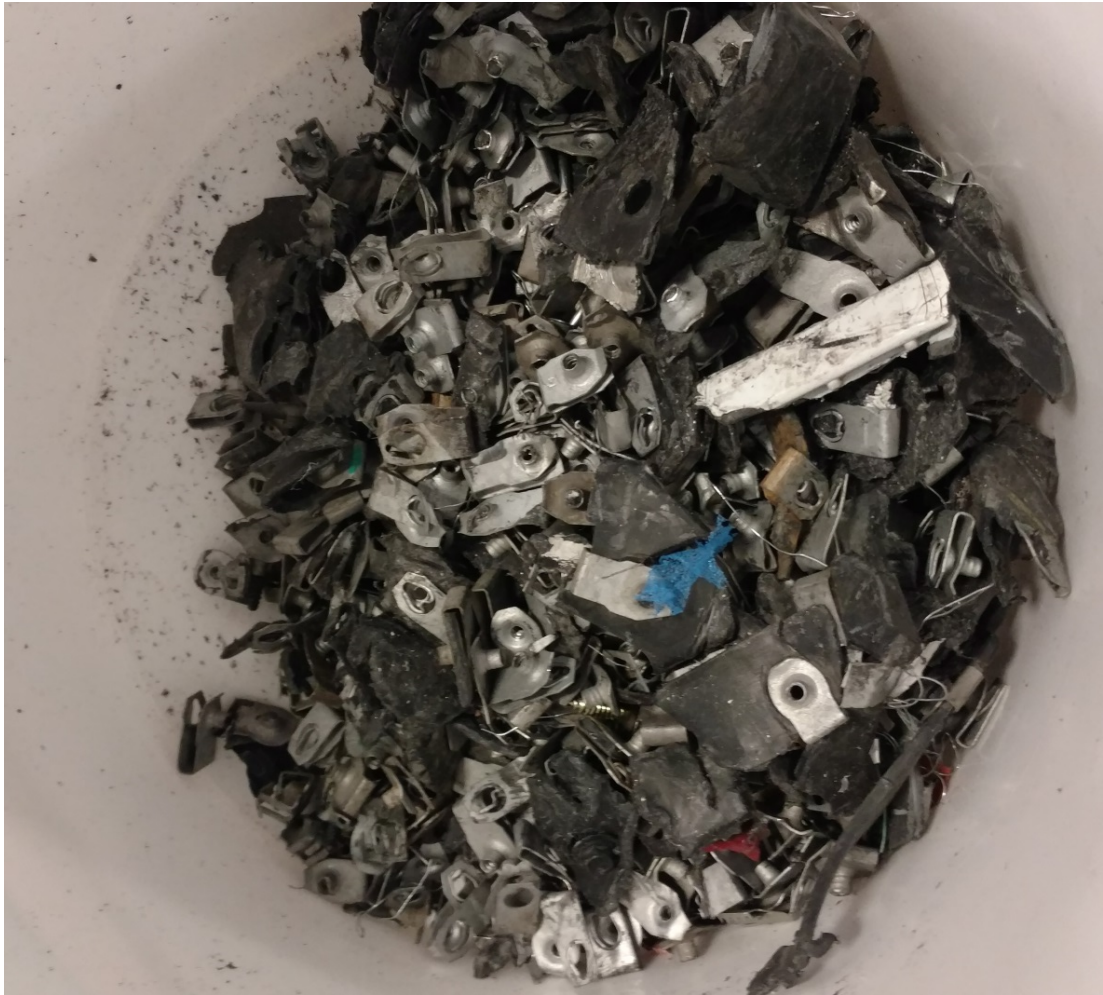
Metal Removal - Magnet Cleanouts

A significant amount of clips were removed via magnets. Shredding prior to finer grinding is key to leaving them largely intact and removing the vast majority and minimizing any metal contamination in the final product

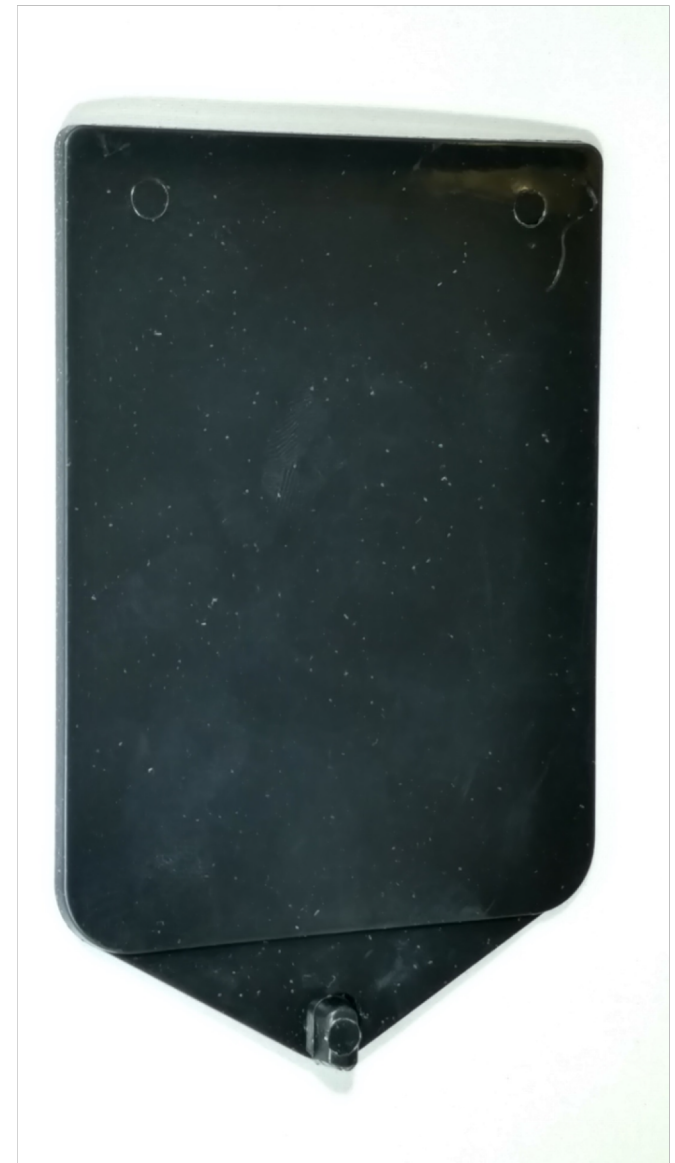
Mechanical properties are quite good and sample molding was very easy. Surface finish displays “pock” marks due to residual paint
